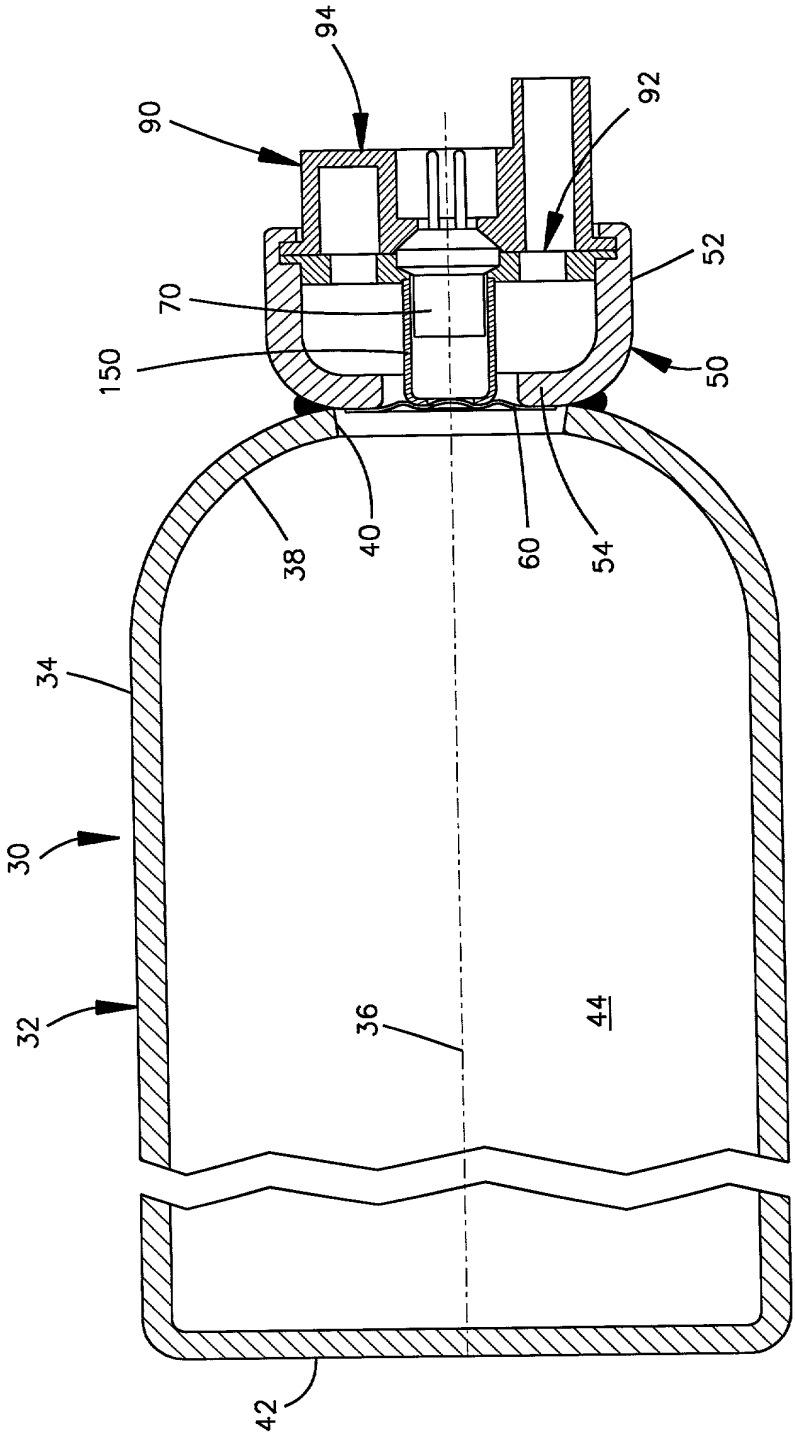
Fig.2

FIG. 2 is a cross-sectional view of the container assembly 10, showing the main body 30, the top flange 32, the bottom flange 42, the interior 44, the central axis 36, the cap 34, the opening 40, the plug 38, the cap screw 70, the nut 90, the washer 92, the seal 50, the gasket 52, and the label 150.
